1234 Main St, Dallas, TX 75123

Prepared For: John Doe, January 1, 2023

BRIAN LINDLEY, Inspector - TREC#23368

PROPERTY INSPECTION REPORT FORM

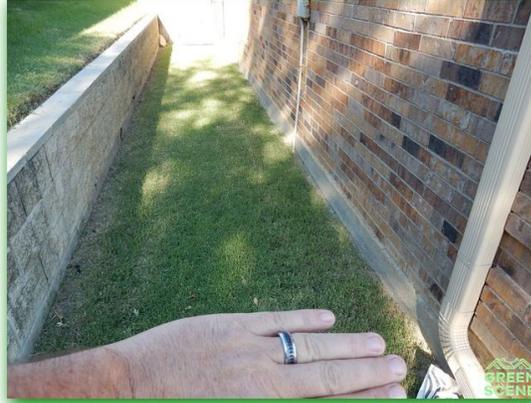
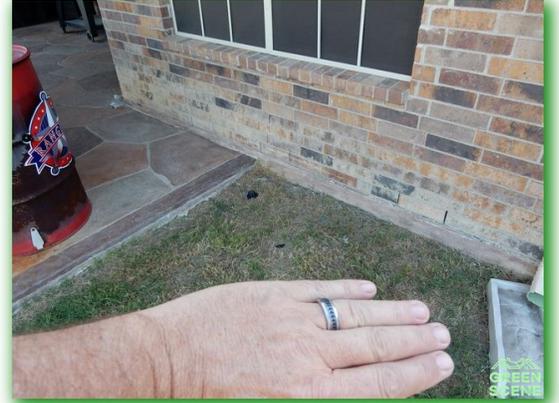
- Marginal site drainage was observed on the south and west sides of the structure. Proper drainage is

needed to help prevent water from standing and/or ponding next to the foundation beam. Corrective measures may be needed if the water stands within 10-feet of the foundation perimeter beam for more than 24-hours.

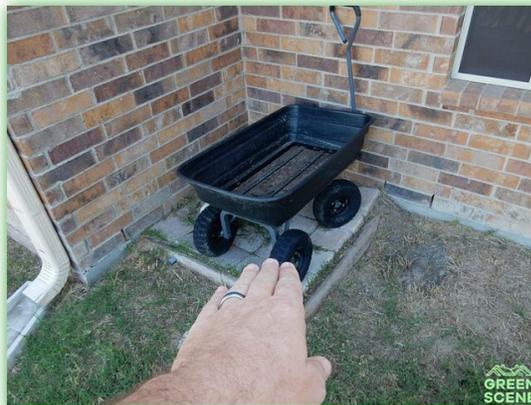
- Fill dirt is needed on the west side of the structure. The low spots in the finished grade (ground) adjacent to the foundation perimeter wall need to be filled in to help prevent water from standing and/or ponding next to the foundation area.

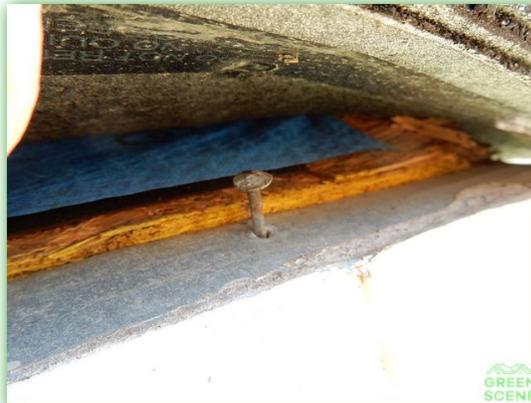
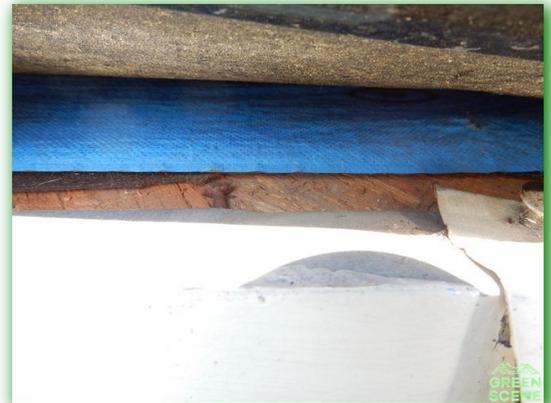
- The roofing material was observed to have **impact damage** in one or more locations. The impact damage may have been caused by a previous hailstorm and should be further evaluated.
- The felt paper was observed to be installed under or not reach the lower metal drip edge flashing detail. The manufacturer installation requires the felt paper to be installed over the top of the metal drip edge flashing, in shingle like fashion, to help prevent water intrusion and/or damage to occur behind the fascia board and soffit/eave areas.

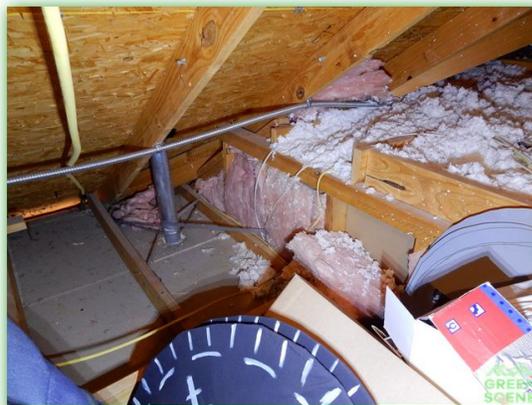
- The attic floor insulation needs to be redistributed in one or more locations.
- The sidewall insulation was observed to be pulling loose in the attic area and should be corrected as necessary.

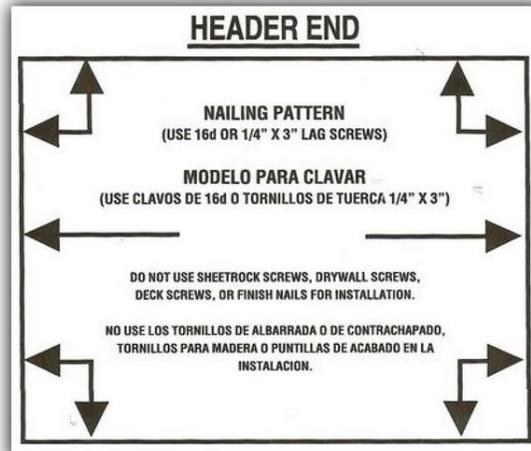
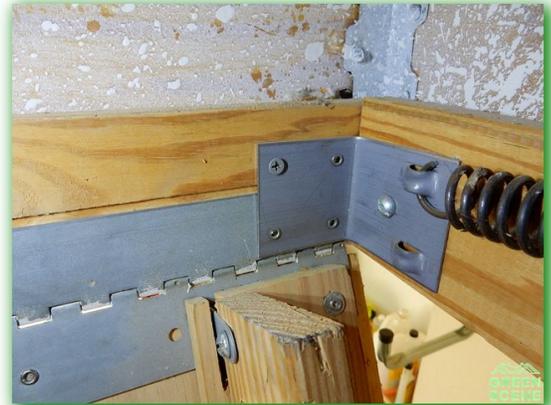
- There is inadequate fireblocking with the garage ceiling mounted attic entry door.. Under current building standards, the entry door between the garage and the attic should have a minimum of a 20-minute fire block rating.
- The attic ladder was observed to be fastened incorrectly and/or with improper fasteners. The attic ladder should be secured in place with 16d nails or 3-inch lag bolts. This condition should be further evaluated and corrected as necessary.

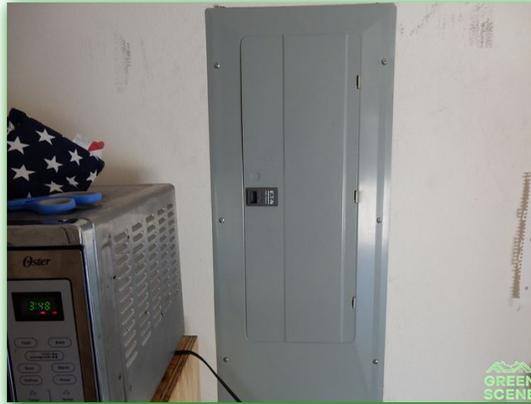
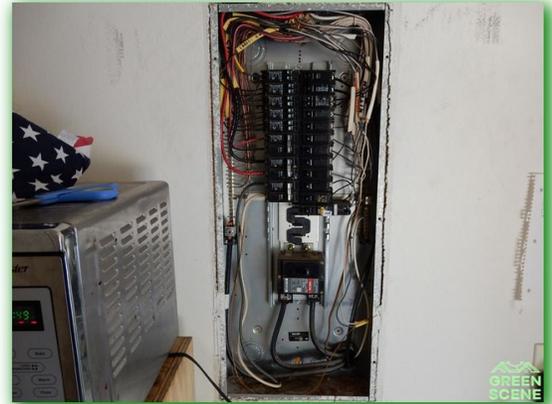
Box Rating and/or Main Disconnect Rating: 200 amps
Box Location: Garage
Cabinet Manufacturer: EATON/Cutler-Hammer
Type of Wiring: Copper

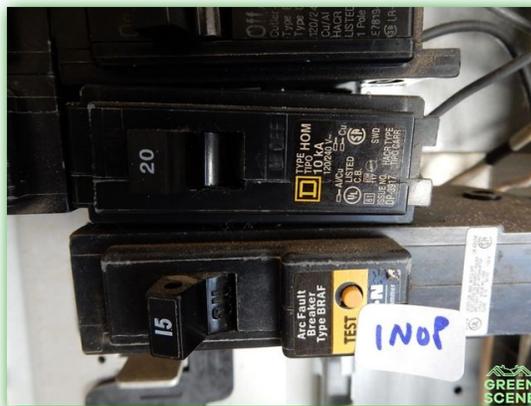
- The wires are entering the electrical cabinet through one bundle instead of multiple knockouts.
- One or more white wires is entering a breaker in the panel box where only black or red wires should be used. Recommend labeling these wires with black marker or black tape to distinguish them from being neutral wires.
- One or more of the breakers do not match the panel box manufacturer's brand. This can lead to issues within the panel box and should be further evaluated and corrected as necessary by a licensed, qualified electrician.
- One or more of the arc-fault circuit interrupter (AFCI) devices in the electrical cabinet did not trip and/or respond properly when tested. This condition should be further evaluated and corrected as necessary.

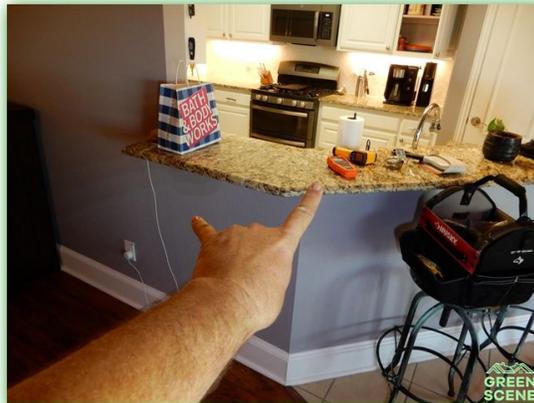
- One or more of the receptacles were observed to be loose at the wall mount in the: south hall bathroom, master bathroom.
- The laundry area receptacle(s) do not appear to be connected to a ground fault circuit interrupter (GFCI) device. Under current electrical standards, all laundry area receptacles should have GFCI protection.
- Not all of the kitchen **area** receptacles appear to be connected to a ground fault circuit interrupter (GFCI) device. Under current electrical standards, all of the kitchen area receptacles should have GFCI protection.

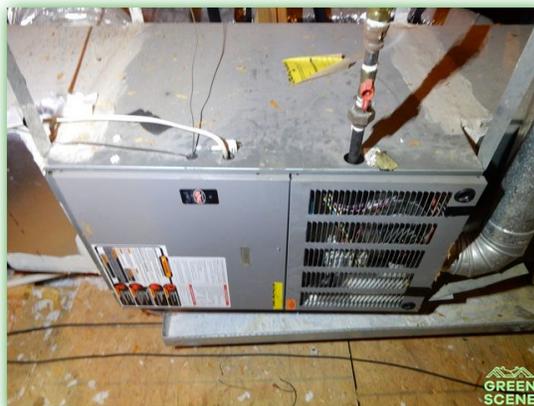
- The heater gas supply line is not equipped with a sediment trap just before the gas appliance connector. This condition does not meet current installation requirements and should be corrected.

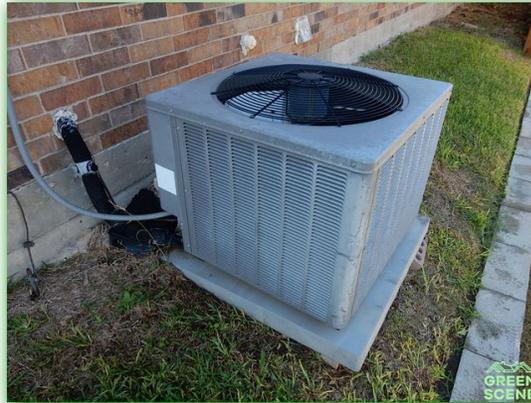
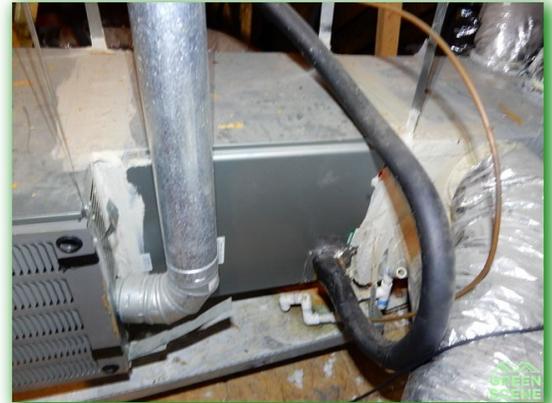
- The outdoor unit of the air conditioning system requires cleaning.

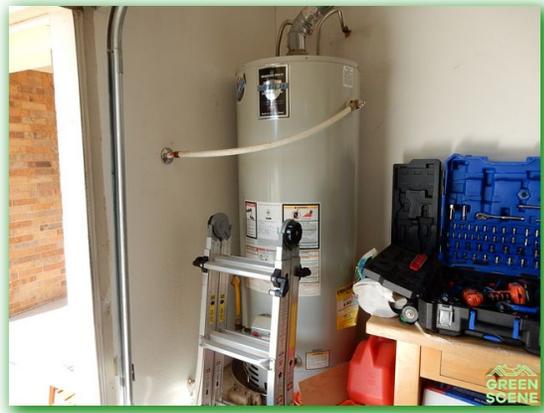
- The TPR valve handle was stiff and hard to operate when spun. Repair or replacement is recommended. These valves are meant to be tested once a year and replaced every three years.
- The temperature and pressure relief (TPR) valve discharge pipe is undersized or not secured. The PEX TPR discharge pipe should be no smaller than 1-inch at any point and fastened in place. Prior to 2018, this may be an “as-built” condition but *per TREC standards of practice we are required to report this condition as a deficiency.*
- The hot water temperature was measured at 149 degrees on the day of the inspection. The temperature should be lowered to 120 degrees for reasons of safety.

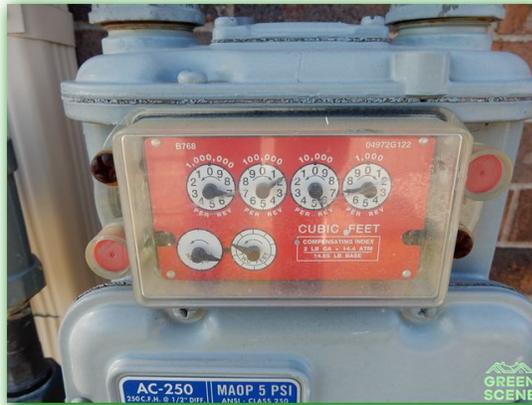
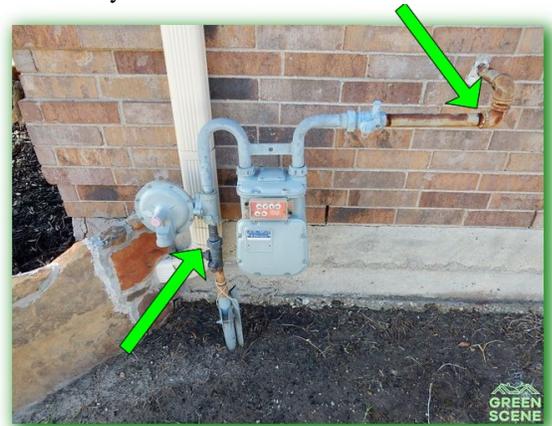
- Movement was detected in the gas meter at the time of the gas check. This indicates a **gas leak** is present and needs to be investigated and repaired as necessary by a Qualified Licensed Plumber. The observation made to support the rendering of this opinion are listed but not limited to the following:
- There was a gas leak detected at the gas meter. The inspector used a gas leak detector to locate the leak. This condition needs to be corrected for reason of safety.

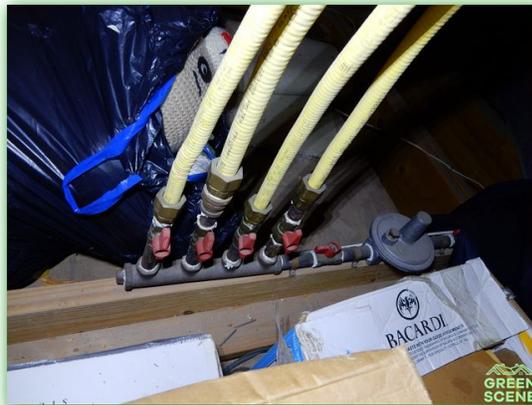
- The corrugated stainless steel tubing (CSST) gas supply line bonding/grounding wire was not observed or not bonded correctly. This wire should be a #8 AWG wire. This condition should be further evaluated by a licensed electrician.

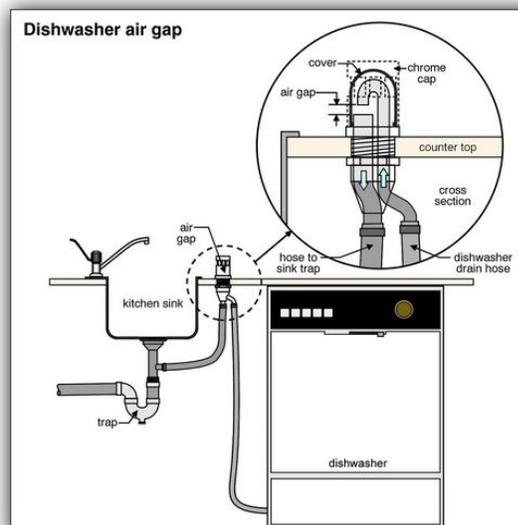
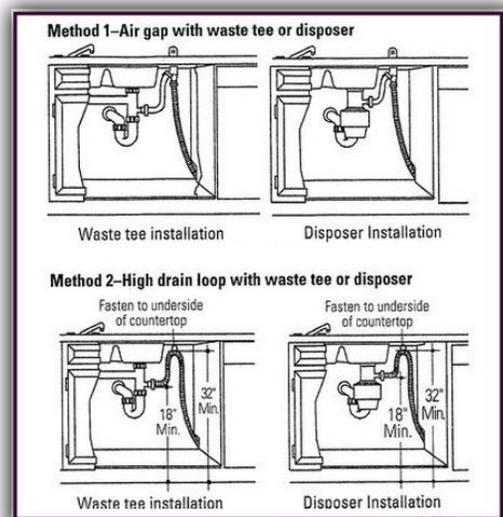
- The dishwasher drain hose is not properly installed to prevent back flow or anti-siphoning. It is recommended that an air gap device or 32" high drain loop be installed in the drain line.

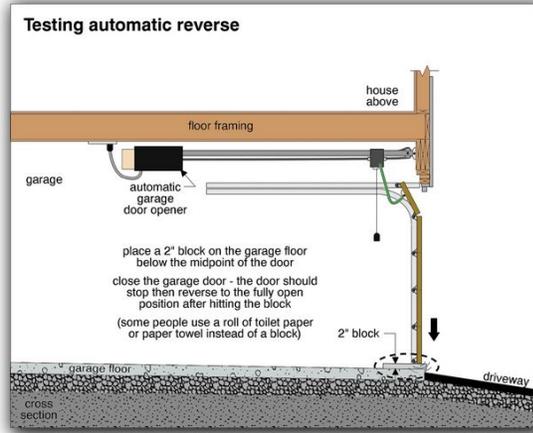
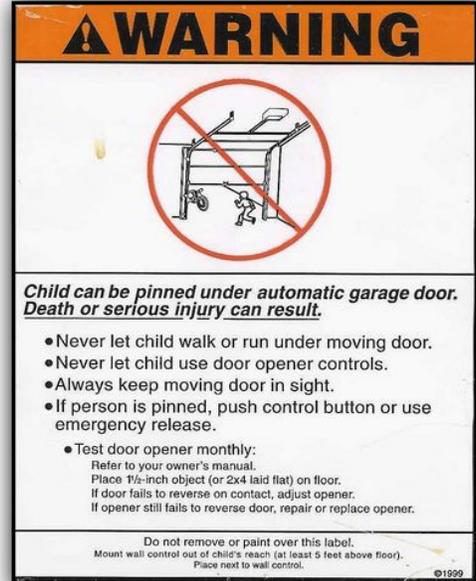
- When an automatic garage door opener is in use, the manual lock should be disabled or removed.
- The garage door opener ***DID NOT*** automatically reverse under reasonable resistance when closing. Improvement may be as simple as adjusting the sensitivity control on the opener.

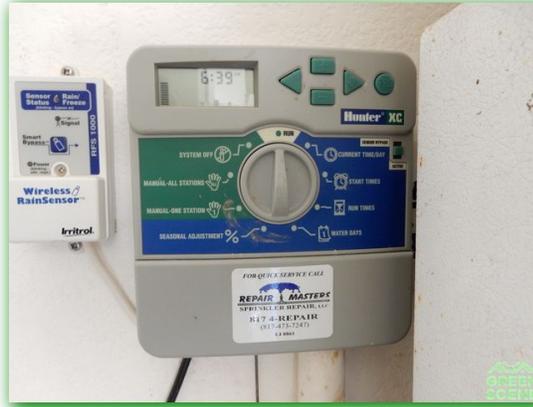
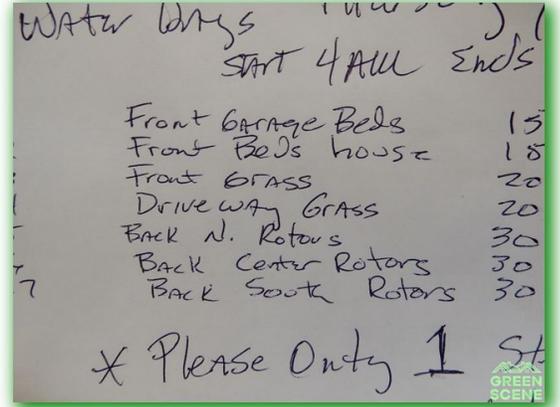
- The irrigation wire conduit does not appear to have the proper UV coating to prevent premature deterioration from the sun.
- One or more of the sprinkler heads need to be adjusted so not to spray water onto the exterior walls, surfaces, fences or windows in station(s); 7.
